Manhole Inspection Summary

Manhole # S270__017MH

Location Address: **1411 S Carey ST**

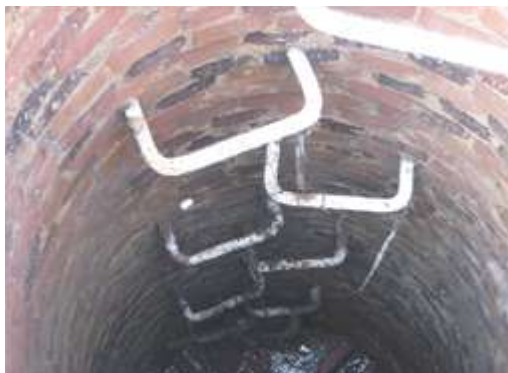
Defect 5

SIGN OF SURCHARGE, AS WELL AS INFILTRATION AT CHIMNEY

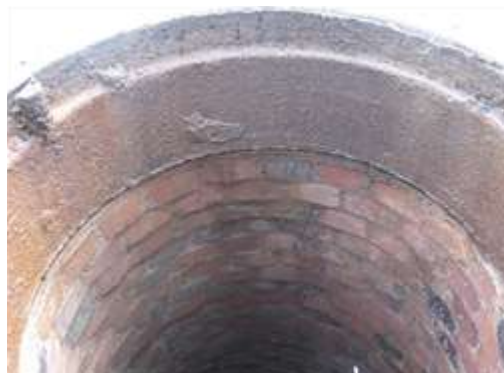
Defect 4

SIGN OF INFILTRATION CHIMNEY FRAME AND LID

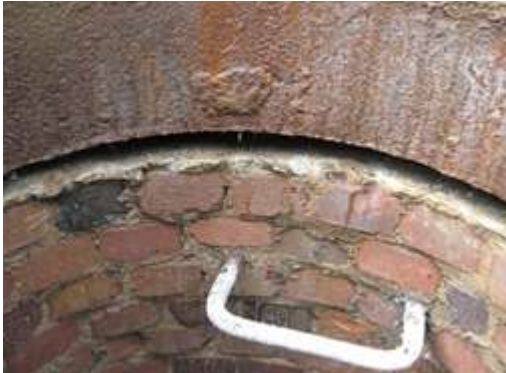
Defect 3

CRACKS IN CHIMNEY, GAP BWTN
FRAME AND CHIMNEY, SIGN OF
INFILTRATION

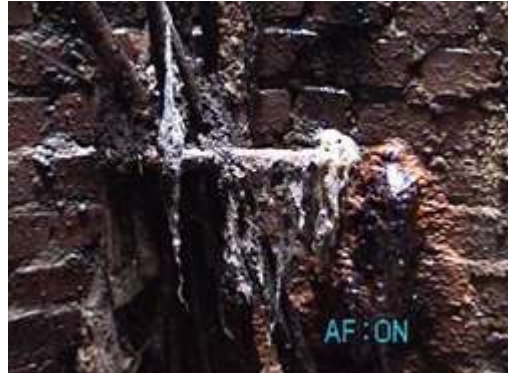
Defect 2

SIGN OF SURCHARGE

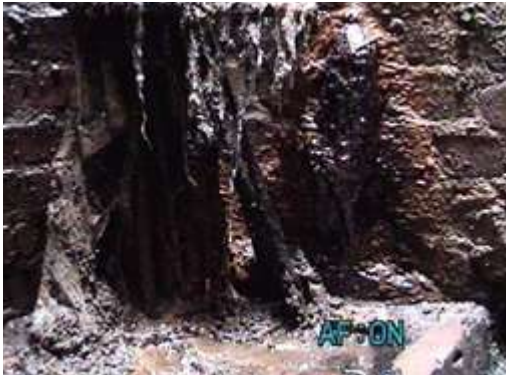
Defect 1

DEBRIS ON BENCH FROM
SURCHARGE AND BARREL
INFILTRATION

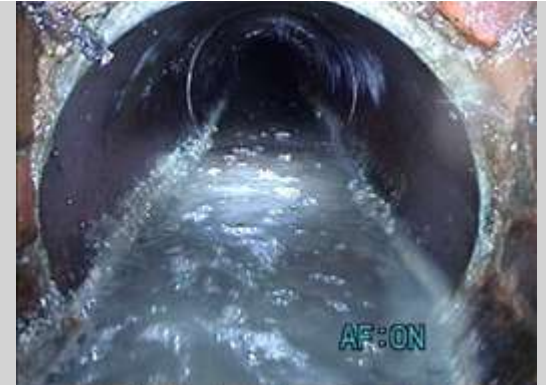
12 O'Clock Outflow

Pipe Height: **12** (in.) Rod and Bar (Angled)
Pipe Material: **Clay** ☐ Pipe Lined
Invert Depth: **14.70** (ft.) Flow Characteristics: **Fast**
Deposits: ☒ None ☐ Mud ☐ Sludge ☐ Debris ☐ Grease
Silt Depth: **0** (in.) Deposits Extent:
Infiltration: **Evidence** Pipe Seal Cond: **Unknown**

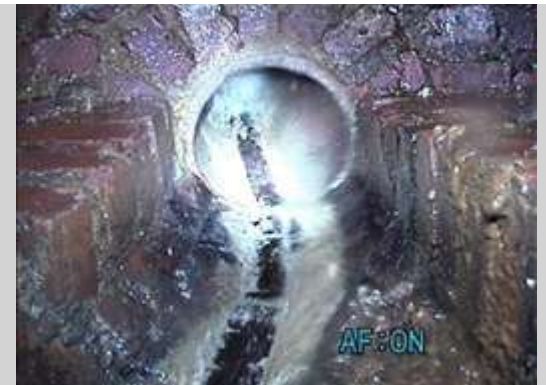
3 O'Clock Inflow

Pipe Height: **8.4** (in.) Rod and Bar (Angled)
Pipe Material: **Clay** ☐ Pipe Lined
Invert Depth: **6.65** (ft.) Flow Characteristics: **Slow**
Deposits: ☒ None ☐ Mud ☐ Sludge ☐ Debris ☐ Grease
Silt Depth: **0** (in.) Deposits Extent:
Infiltration: **Evidence** Pipe Seal Cond: **Unknown**

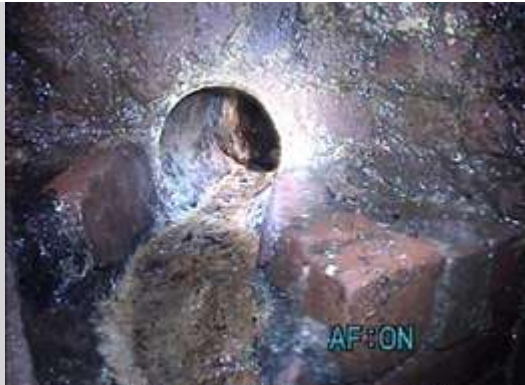
7 O'Clock Inflow

Infiltration: **Evidence**

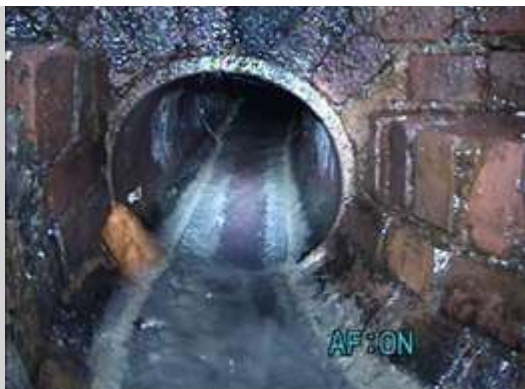
9 O'Clock Inflow

Infiltration: **Evidence**
